# Manhole Inspection Summary

Manhole # S45G\_\_002MH

Insp Date: **7/15/08 11:13 AM**

**Location** Address: **202 1/2 s castle st**

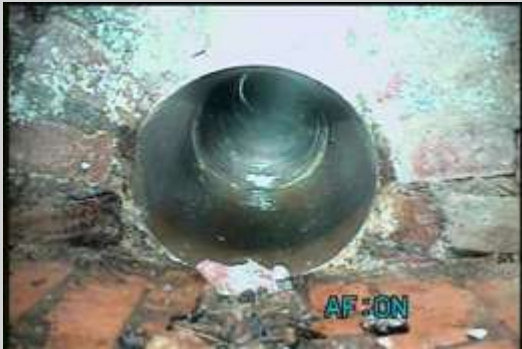
12 O'Clock Outflow

8 in. Circular Gravity Sewer  
Pipe Out @ 12 O'Clock

Infiltration: **None** Pipe Seal Cond: **Unknown**
